**Level One Supervision –  
Statement of Compliance**

**Level One Supervision  
Maple Lane Estate  
Stage 2  
Ballarat-Carngham Road  
WINTER VALLEY**

**Report No: 121207-B001-B012**

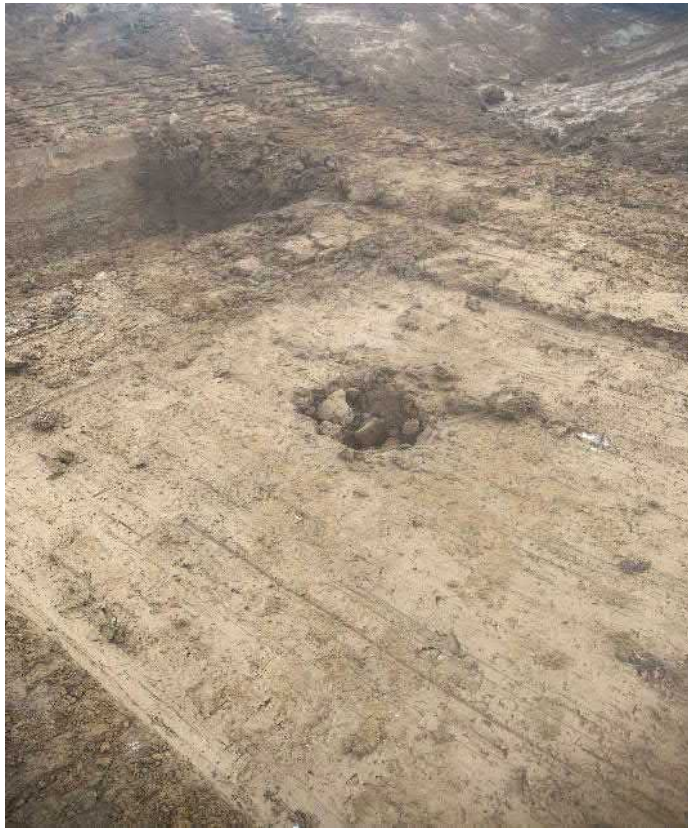
**Test 1**

The constructor had placed the first layers of fill over the small outlying area of dam backfill on the proposed lots 15 and 16 as advised in previous visit to the site, so as to stop the area from filling with water due to the expected rain in the coming days. The constructor had cut a test pit at two depths and a test was carried out on each depth of 1000 mm below finished fill, and 600 mm below finished fill. The onsite material used appeared to be well compacted and close to optimum moisture content. The constructor has been advised to await laboratory testing results before any further filling is to be carried out in this area. The constructor has continued to excavate the fill areas on the western side of estate, and will contact when they require an inspection on this area.

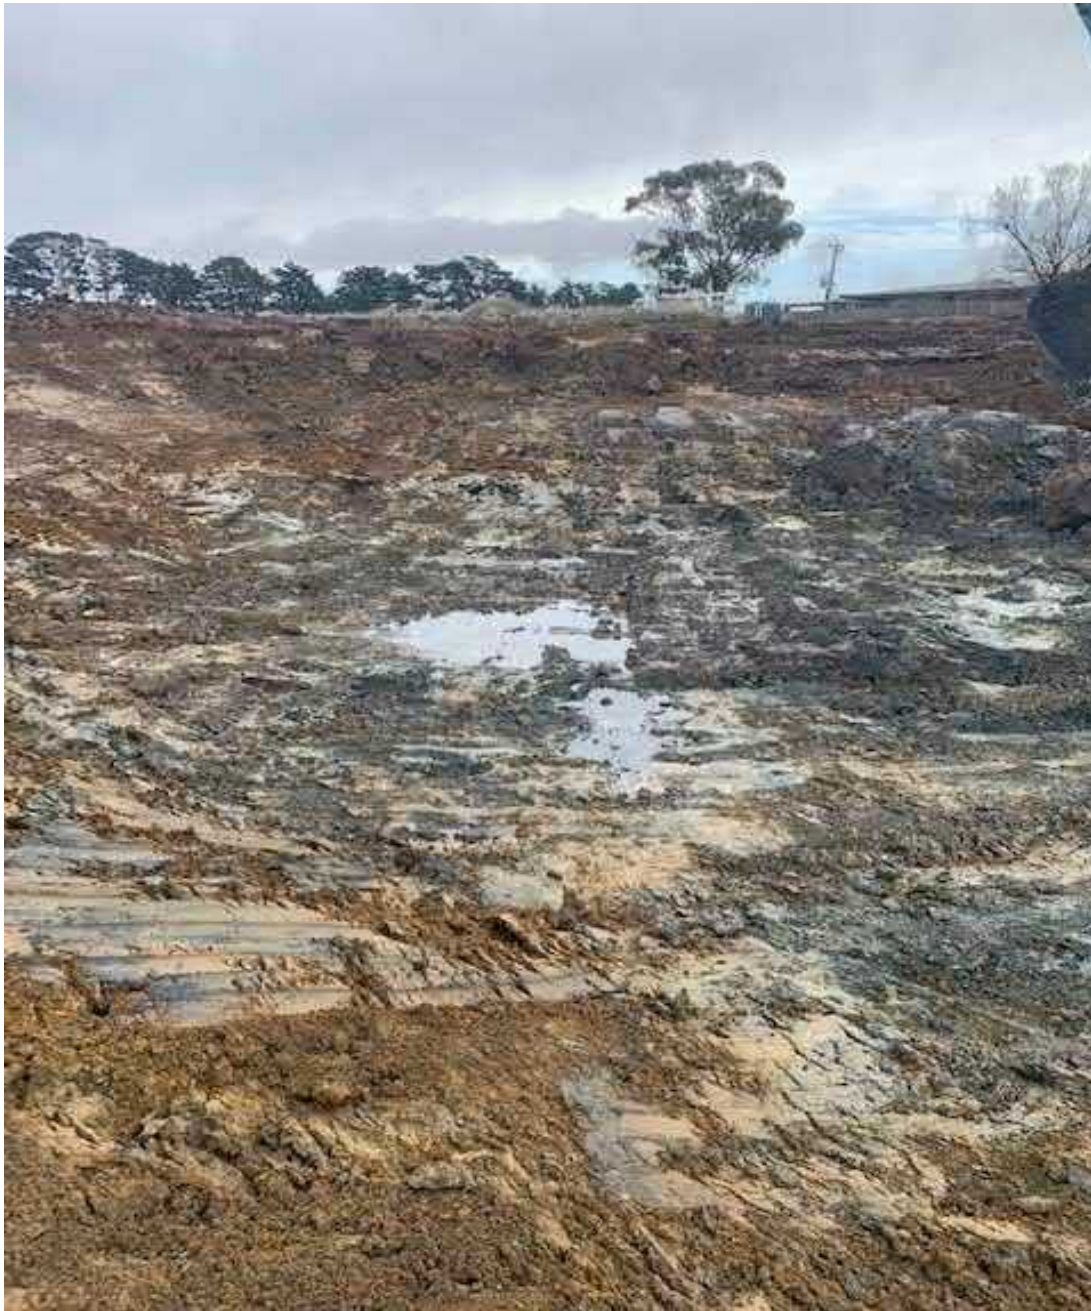
**Excavated Dam area**

**OBSERVATIONS:** The constructor has continued excavation works within the existing dam, removing the moisture affected material and any loosened basaltic floaters. This has created "moonscape" base which appears suitable to commence filling works upon.

**CONCLUSIONS AND REMARKS:** The constructor was advised that the prepared area appears suitable to commence filling works within. The constructor was advised to place a travel coat within this area to the highest rock, to create a level base to commence filling works from. This travel coat should be well compacted prior to commencing filling works. Should this area be exposed to any significant weather events prior to filling works taking place, it is recommended that a follow up inspection be carried out.

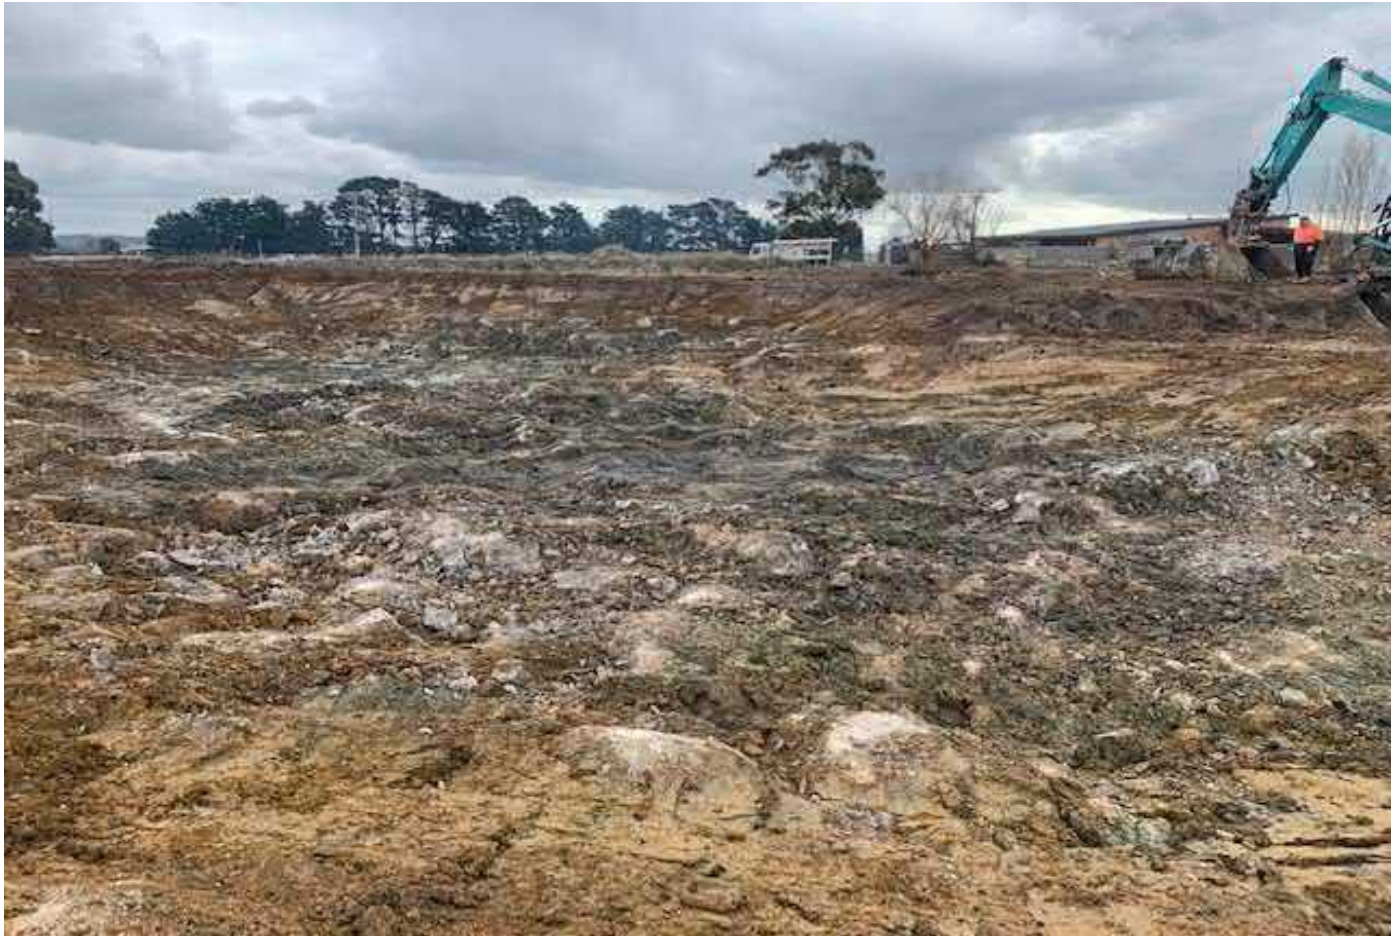
**Excavated Dam area**

**OBSERVATIONS:** The constructor has continued excavation works within the existing dam, removing moisture affected material & rock as previously advised. The edges of the excavated area have been battered on a 45 degree angle to ensure safety & suitable access for filling & compacting.

**CONCLUSIONS AND REMARKS:** The constructor was advised that the prepared area appears suitable to commence filling works within. The constructor was advised to ensure no pooling water is allowed to stand within this area as it is the lowest point within the proposed area. Should this area be exposed to any significant weather prior to filling works taking place, it is recommended that a follow up inspection be carried out.

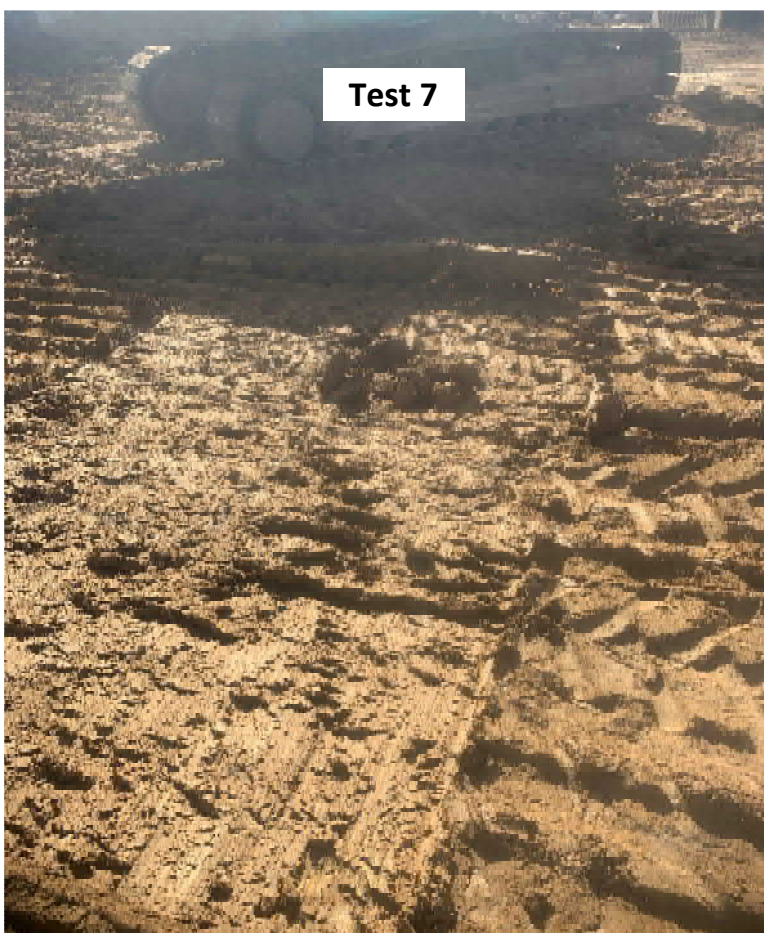
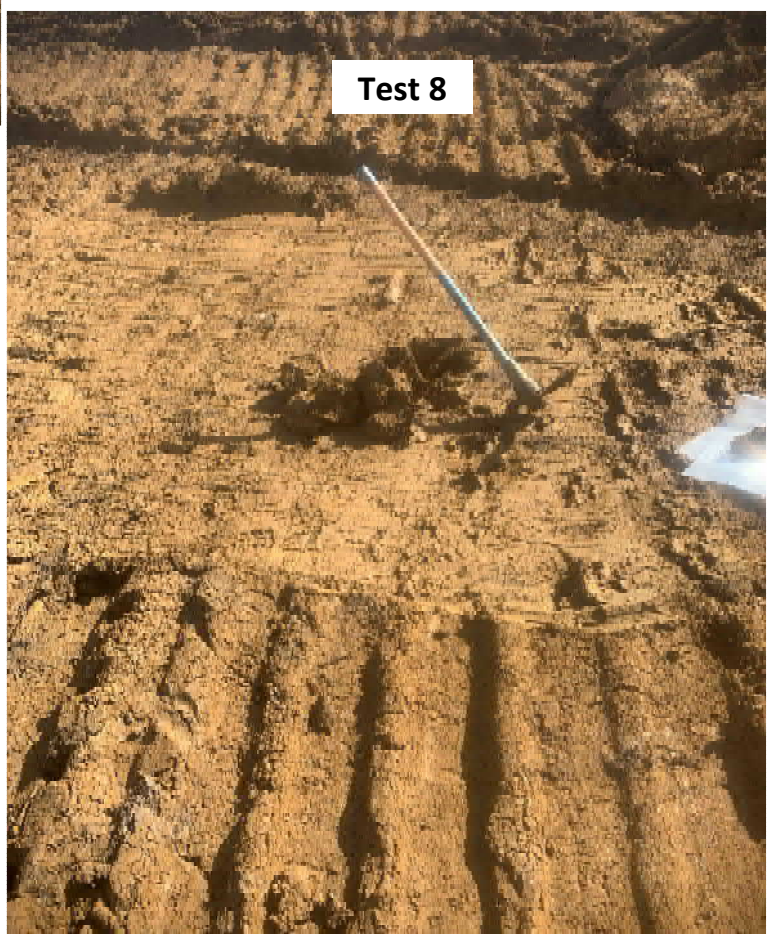
**Comments, Details & Observations:**  
 The constructor had placed the next layer of fill over the western section of the dam backfill area to bring the entire fill area to the same height. The approved on site material was used and was compacted using a pad foot roller. 2 tests were carried out on the material at each end of the fill area which covered the proposed house lots 15, 16 & 17. The material appeared to be well compacted, however it appeared to be slightly wet of optimum moisture content, and therefore may require some re-conditioning. The constructor has been advised to await lab results before any further fill works.

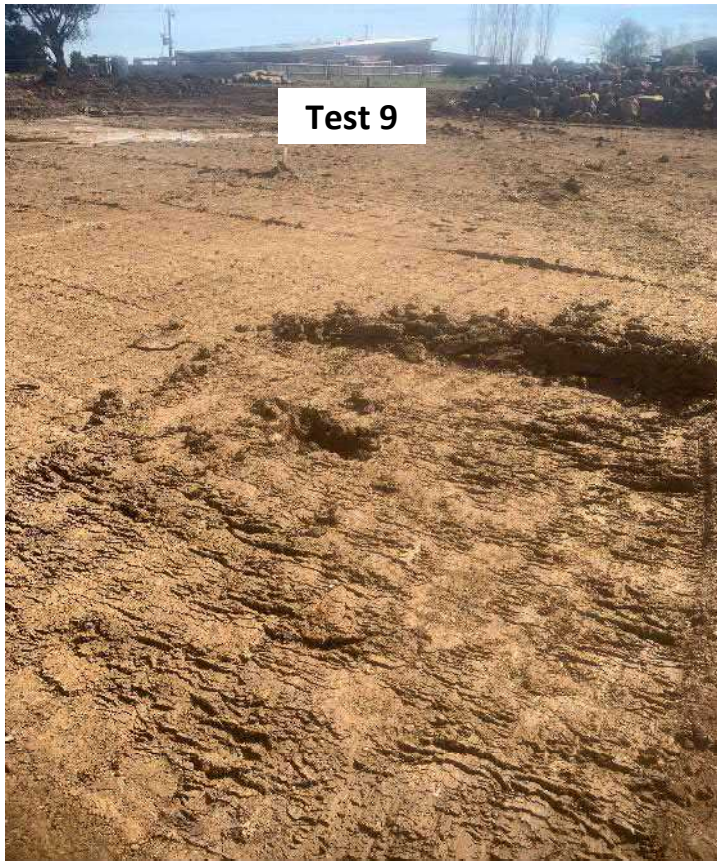
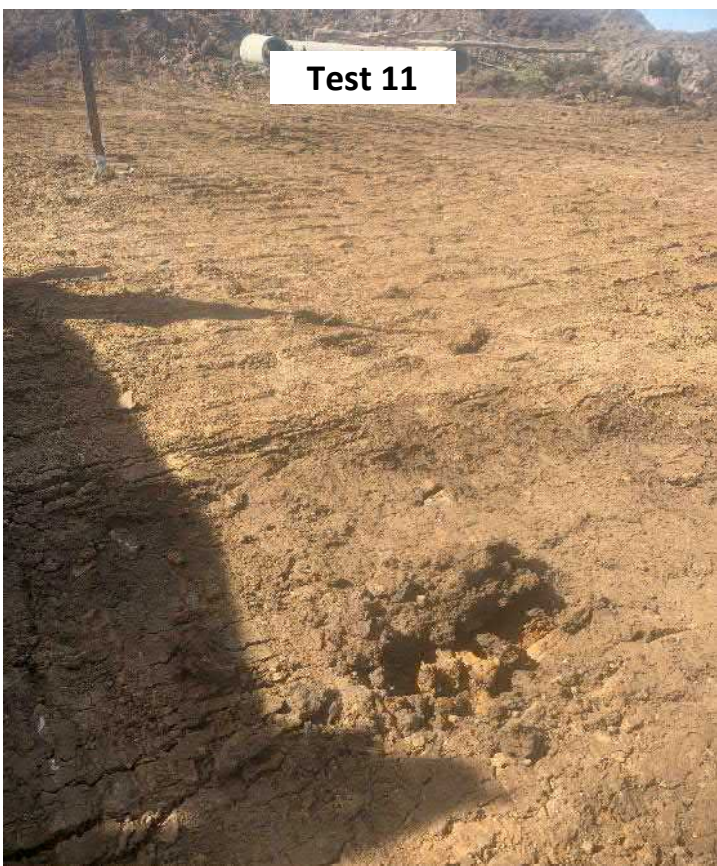
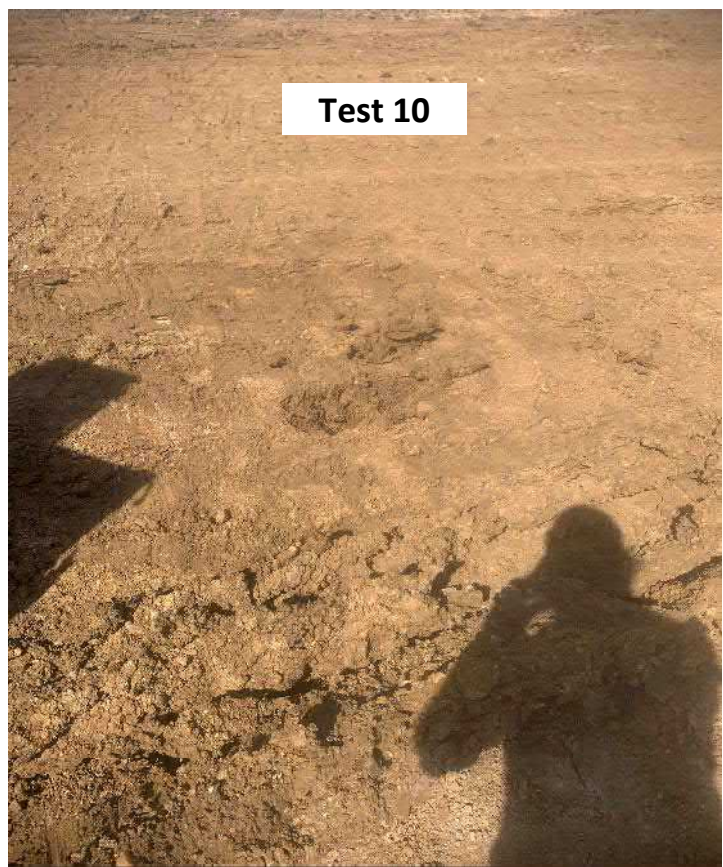
The constructor had placed the final layer of material across the entire section of fill that covers the proposed house lots 15, 16 & 17 as the area was now at a level depth after the previous visit. A 300 mm layer was placed using the approved on site material, and was compacted using a pad foot roller. 3 tests were carried out across the fill area, with the material appearing to be well compacted, however possibly slightly wet of optimum moisture content.

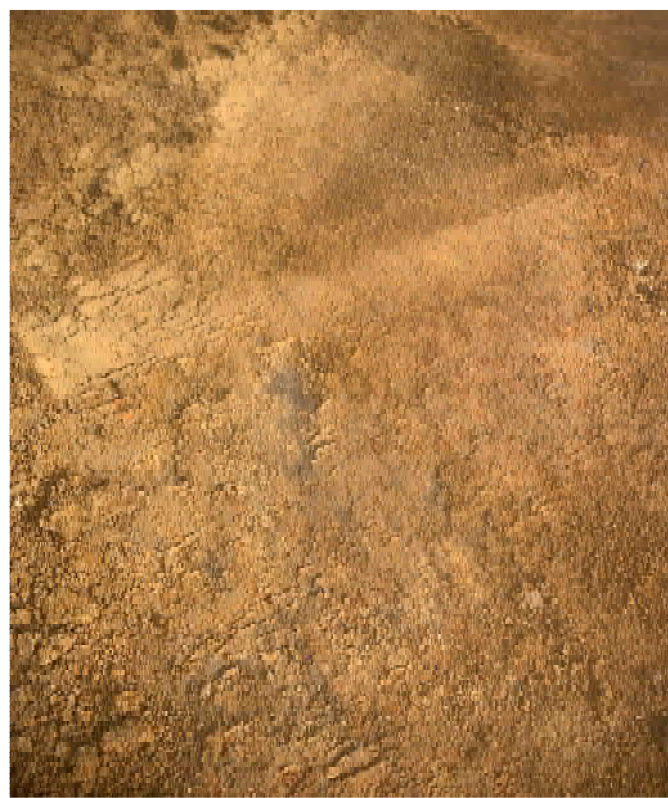
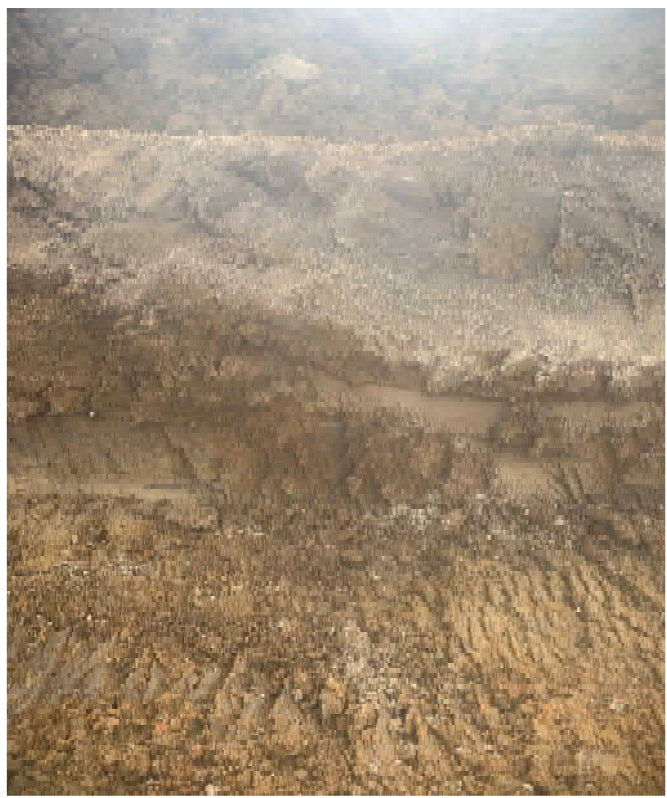
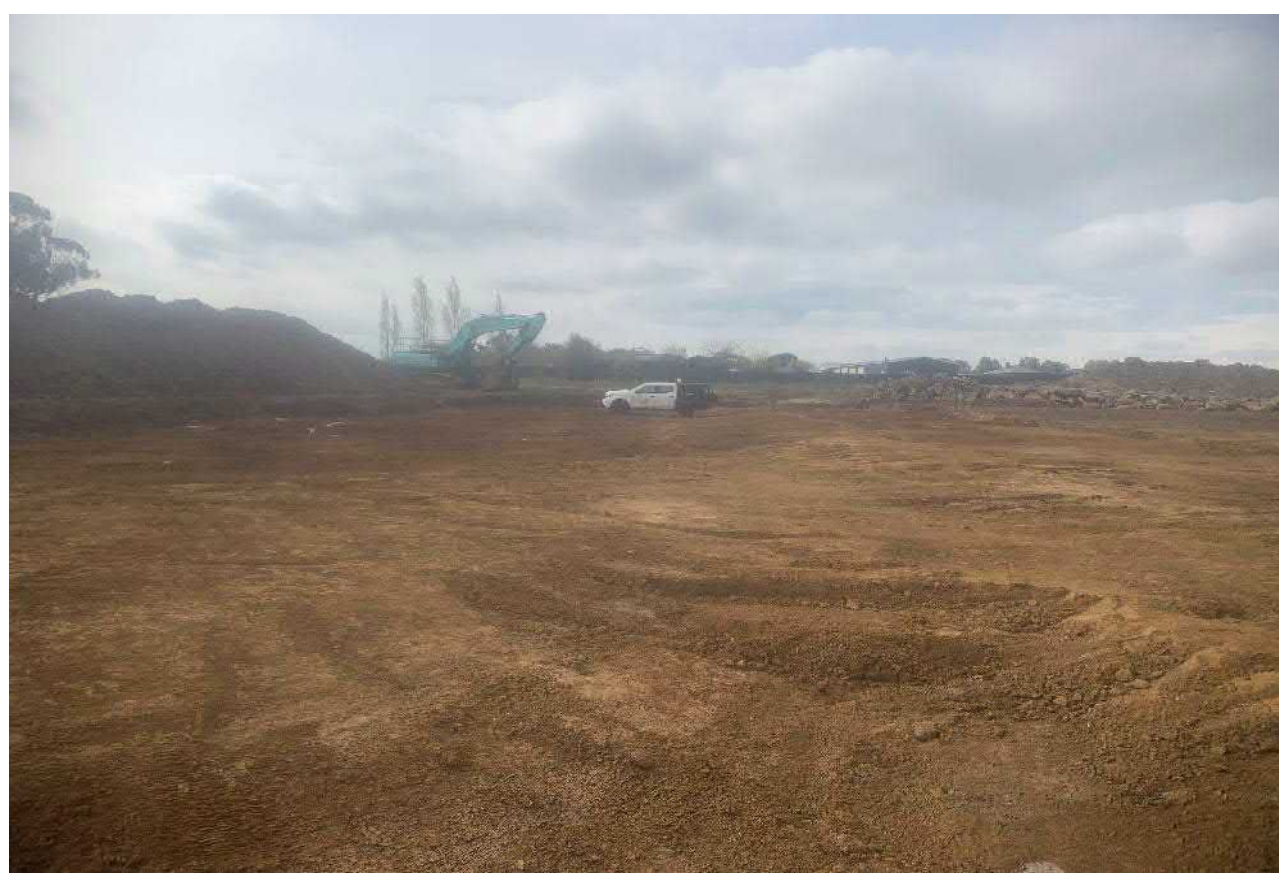
The constructor was advised that the prepared area appears to be suitably excavated to a stable base and is ready to commence filling works. The constructor was advised that the area be rolled with a pad foot roller prior however to ensure that the area is suitably compacted and to create scarification so the fill will bind once filling commences. The constructor was further advised that if the area was exposed to any weather conditions that may effect the exposed material between today's inspection and the commencement of filling works, remedial works are to take place on the area before filling can commence.

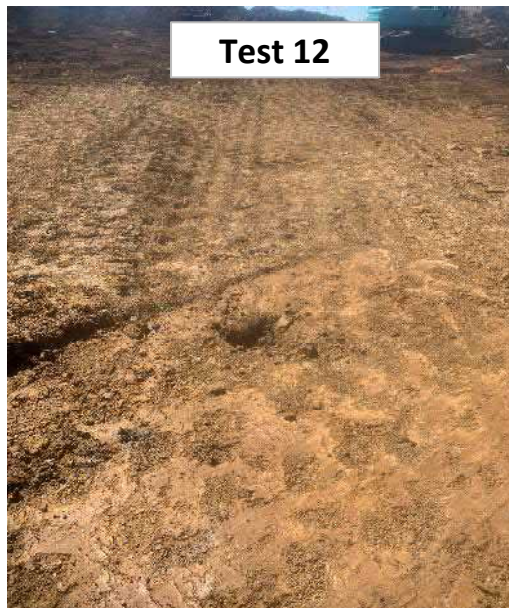
**Test 12**

**Comments, Details & Observations:**  
 The constructor had commenced filling works on the proposed house lot 4-9 using the approved on site material. The layer placed was 300 mm in thickness and was the first layer compacted over these house lots. One test was carried out on each lot, with six tests carried out in total. The material was compacted using a pad foot roller and appeared to be well compacted. The material also appeared to be well moisture conditioned, but did vary from lot to lot. Lots 2 & 3 were not tested as they still required some re-working and possibly a change to the material used. These lots will be tested at another visit. The constructor was advised to await laboratory results before any further filling works.

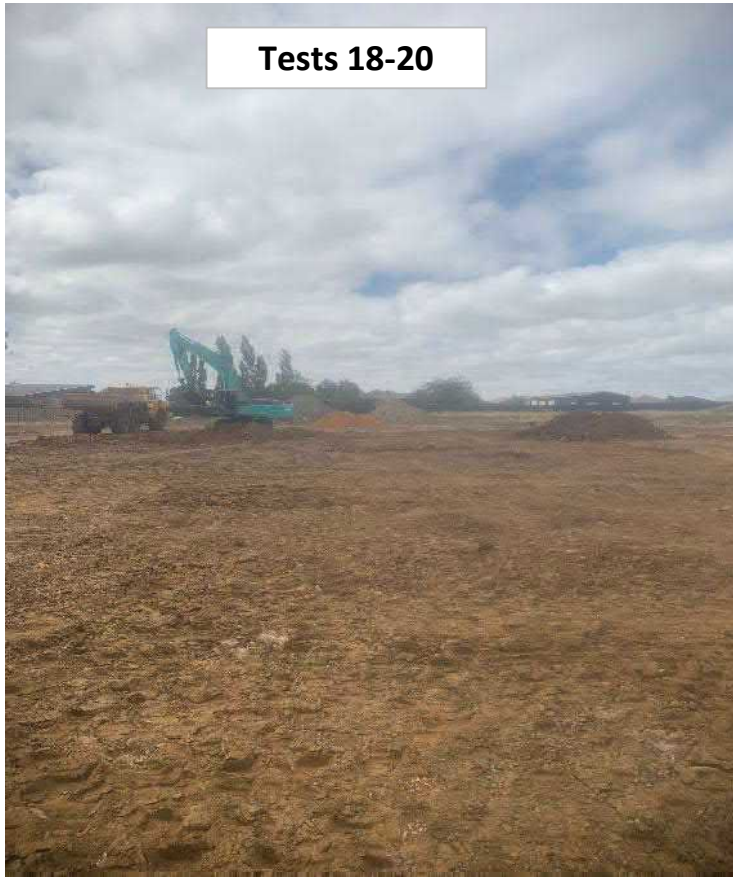
**Tests 18-20**

**Comments, Details & Observations:**  
 The constructor has placed and compacted the next 300 mm layer of fill over the proposed house lots 4 - 9 using the approved on site material. The material was placed and compacted using a pad foot roller. The material appeared to be well compacted, however it also appeared to be slightly dry of optimum moisture content in some areas of the fill zone. One test was carried out on each house lot, with six tests being carried out in total. The current fill height is approx. 300 below the proposed finished fill height. The constructor has been advised to await laboratory results before further fill works.

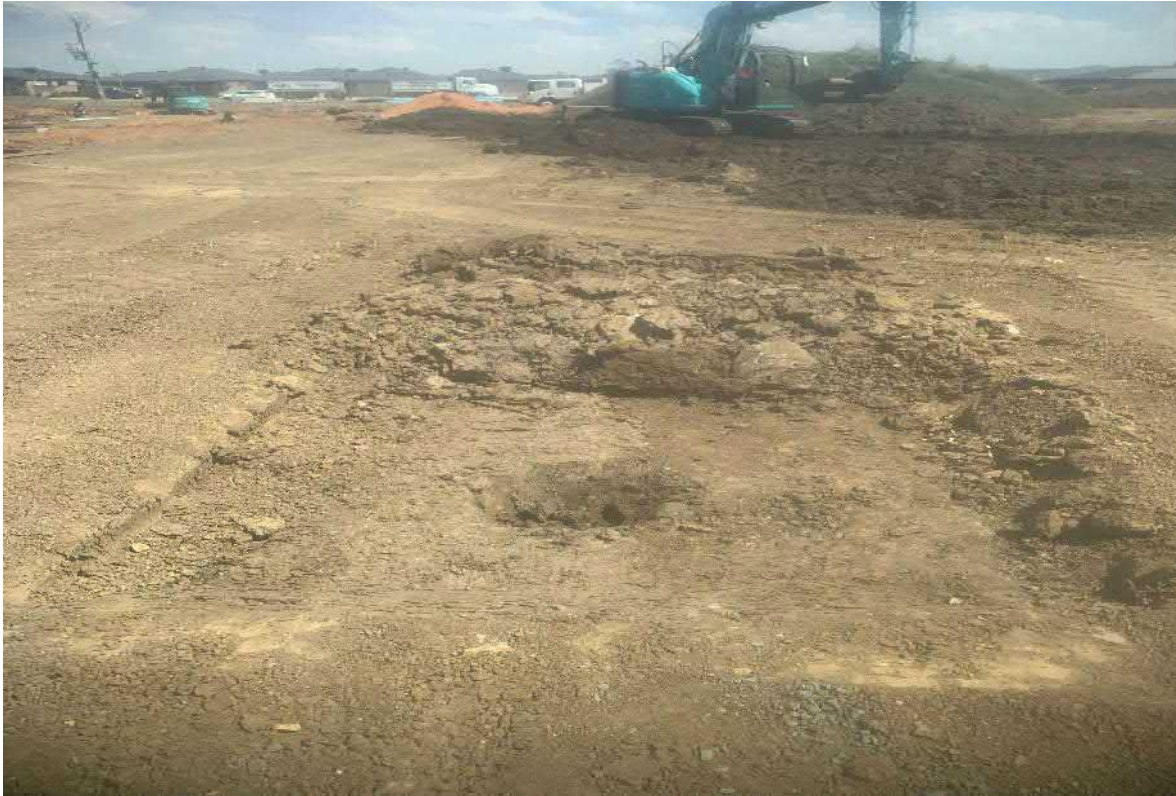
**Test 32**

**Comments, Details & Observations:**  
 The constructor had been advised that the area of the proposed house lot number 6 had failed on moisture ratio and required a retest. The constructor had reworked the area of lot 6 and prepared the lot for a retest using the approved on site material. One test was carried out on the area on the proposed finished fill level. The material appeared to be well compacted and well conditioned appearing close to the optimum moisture content. The constructor has been advised to await the laboratory results before any further works on the area.
