**Level One Supervision –  
Statement of Compliance**

**Level One Supervision  
Maple Lane Estate  
Stage 2  
Ballarat-Carngham Road  
WINTER VALLEY**

**Report No: 121207-B001-B012**

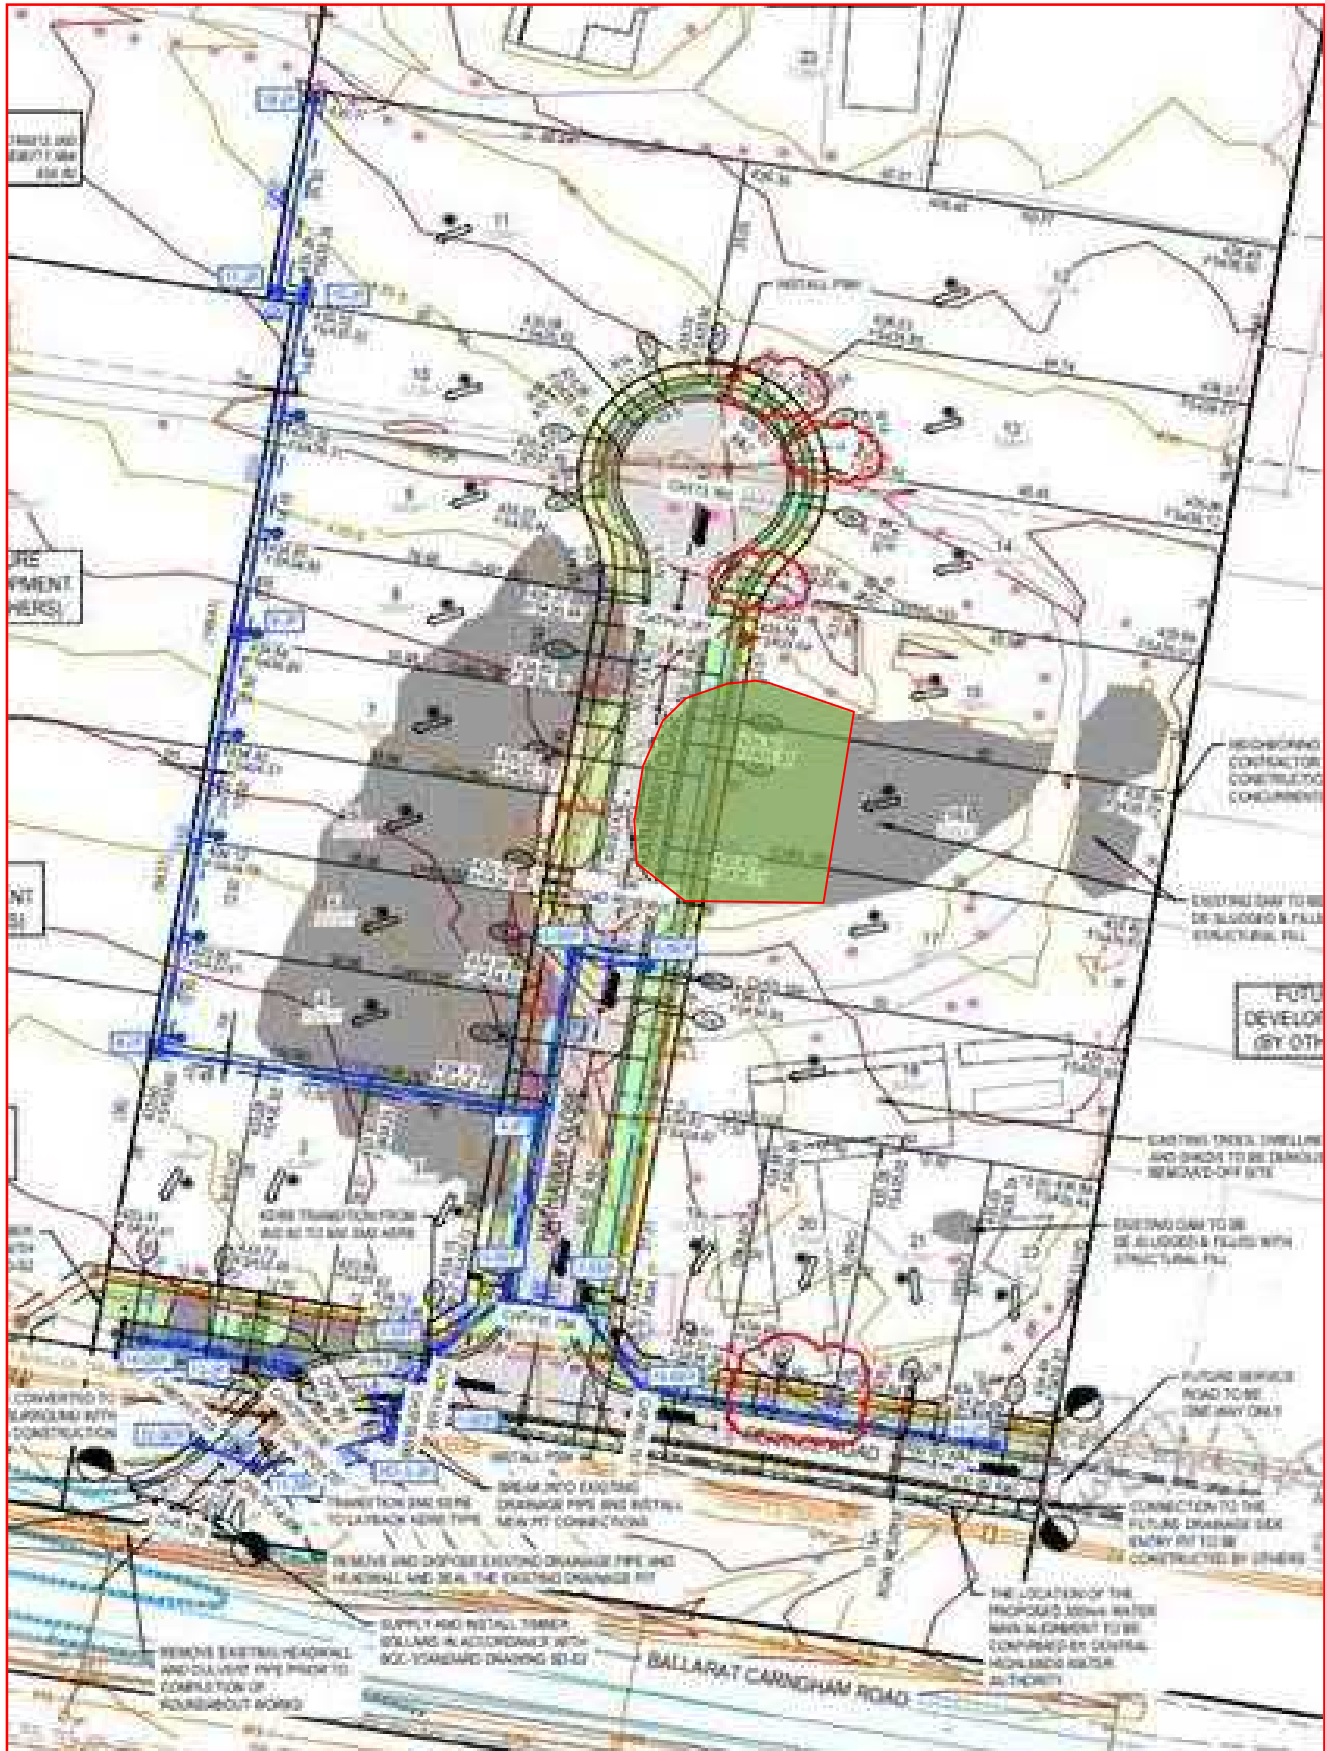
Approx. location of inspected area

**OBSERVATIONS:** The constructor has continued excavation works within the existing dam, removing moisture affected material & rock as previously advised. The edges of the excavated area have been battered on a 45 degree angle to ensure safety & suitable access for filling & compacting.

**CONCLUSIONS AND REMARKS:** The constructor was advised that the prepared area appears suitable to commence filling works within. The constructor was advised to ensure no pooling water is allowed to stand within this area as it is the lowest point within the proposed area. Should this area be exposed to any significant weather prior to filling works taking place, it is recommended that a follow up inspection be carried out.

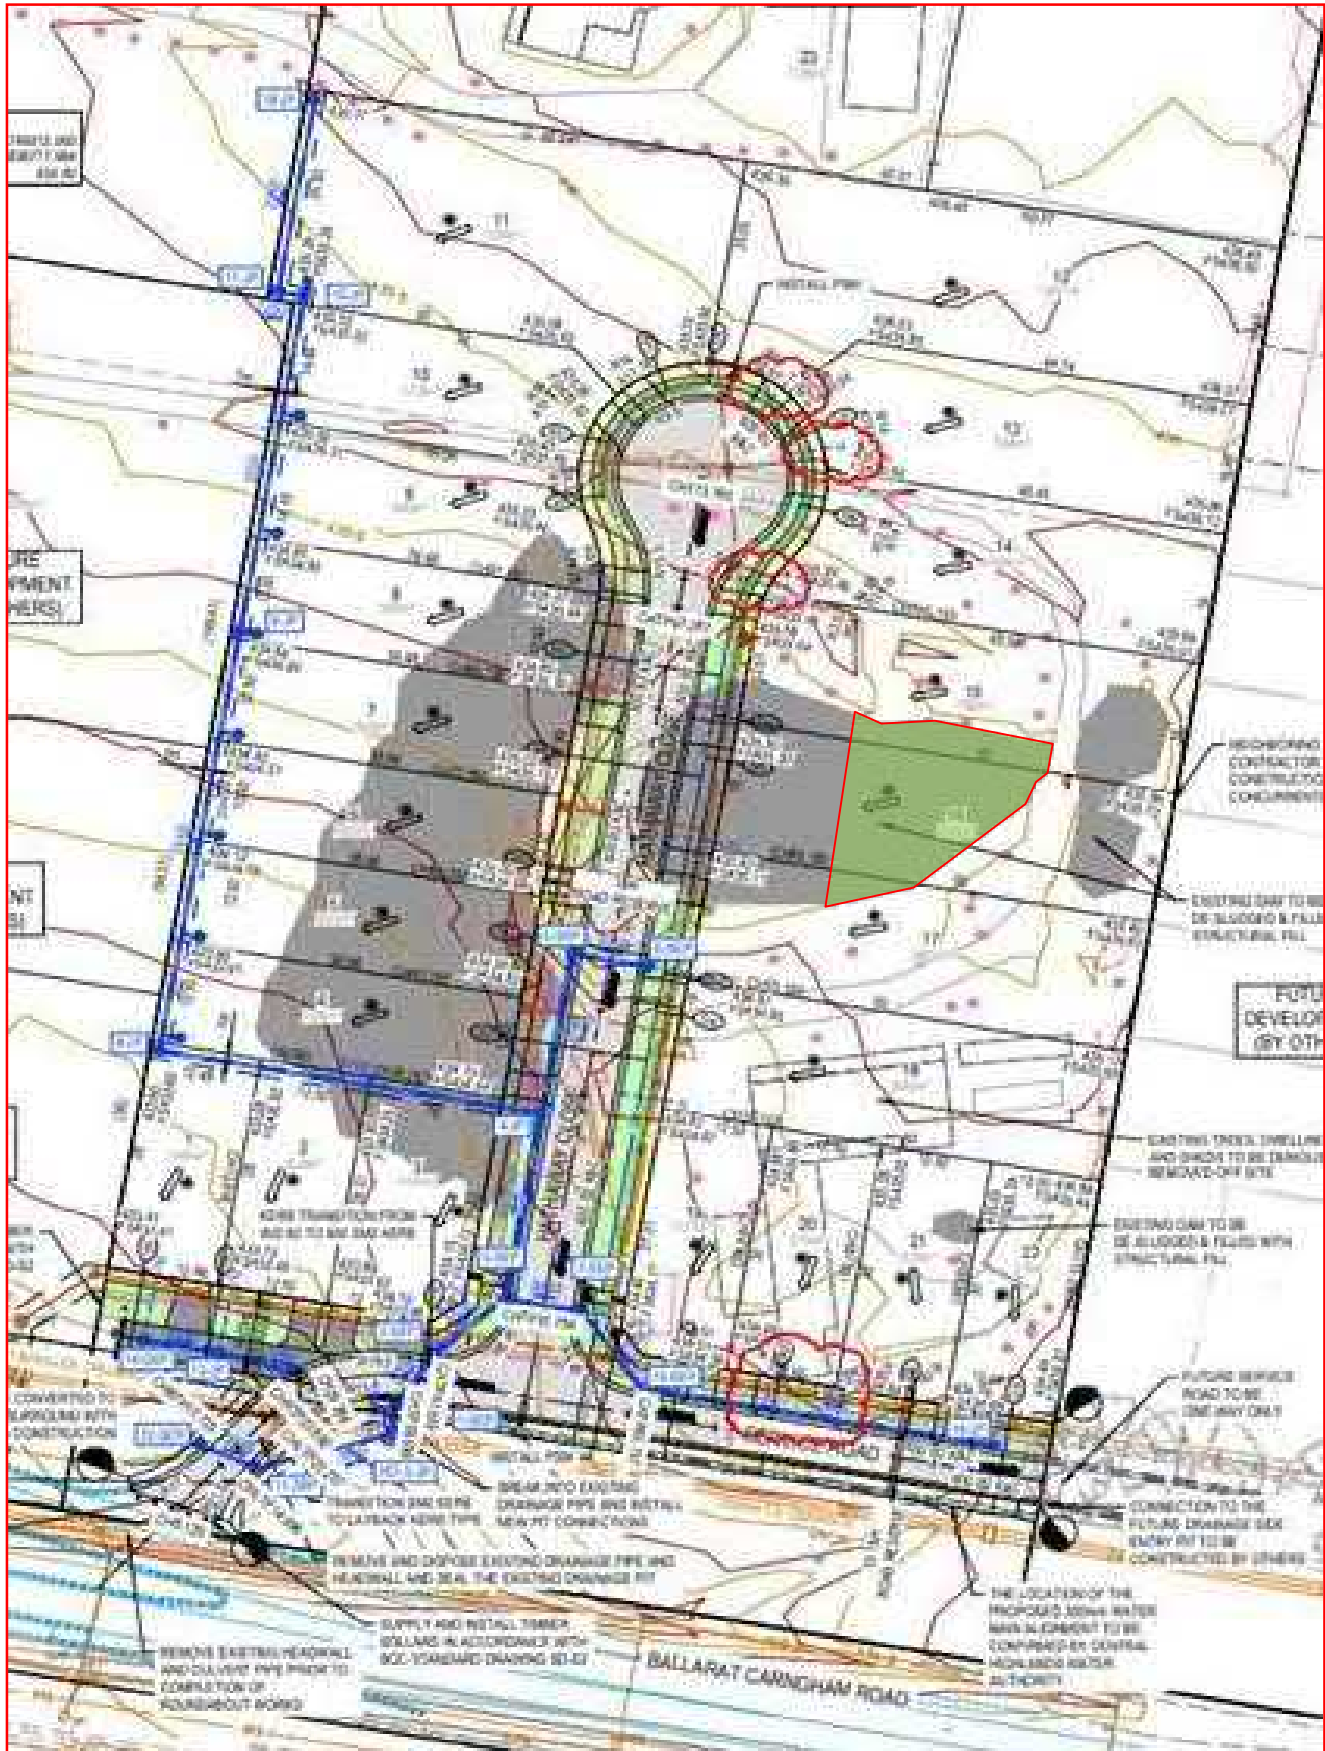
Approx. location of inspected area

**OBSERVATIONS:** The constructor has continued excavation works within the existing dam, removing the moisture affected material and any loosened basaltic floaters. This has created "moonscape" base which appears suitable to commence filling works upon.

**CONCLUSIONS AND REMARKS:** The constructor was advised that the prepared area appears suitable to commence filling works within. The constructor was advised to place a travel coat within this area to the highest rock, to create a level base to commence filling works from. This travel coat should be well compacted prior to commencing filling works. Should this area be exposed to any significant weather events prior to filling works taking place, it is recommended that a follow up inspection be carried out.
